# Access Compliance Report Public Rights-of-Way (Curb Ramps)

Main Street: N/A Cross Street: HARBOR\_BLV Location: SW

ADA ID: RPRK220222170705 Ramp Type: Type 6 - Directional 1 Initial Pass/Fail: Fail Overall Compliance: No Severity Score: 2

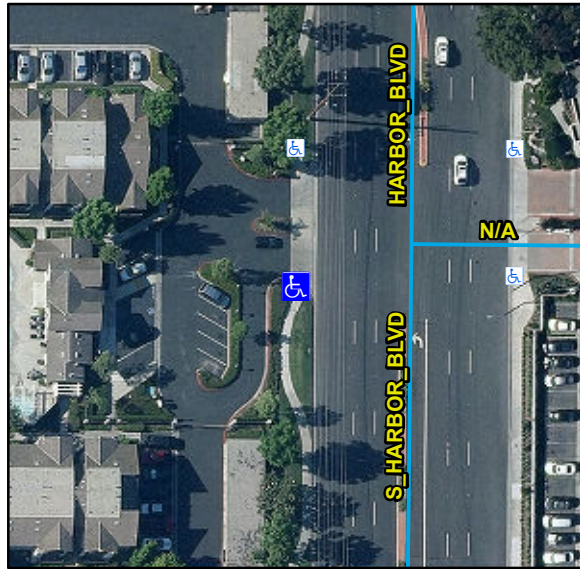
| Compliance | Description | Data | Compliance | Description | Data |
|---|---|---|---|---|---|
| No | Ramp Cross Slope (%) | 2.7 | N/A | Flare Traversable LT | N/A |

Remove & Replace Entire Ramp.

R304.5.3, STD 1115
