# Access Compliance Report Public Rights-of-Way (Curb Ramps)

Main Street: N/A Cross Street: HARBOR\_BLV Location: NW

ADA ID: RPRK220222171029 Ramp Type: Type 1 - Perpendicular Initial Pass/Fail: Fail Overall Compliance: No Severity Score: 2

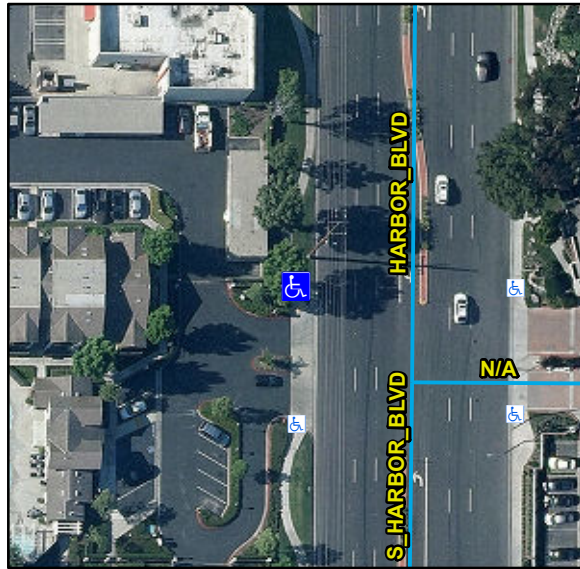
| Compliance | Description | Data | Compliance | Description | Data |
|---|---|---|---|---|---|
| No | Ramp Cross Slope (%) | 2.6 | N/A | Flare Traversable LT | N/A |

Remove & Replace Entire Ramp.

R304.5.3, STD 1115
