# Access Compliance Report Public Rights-of-Way (Curb Ramps)

Main Street: ROMELLE\_AVE Cross Street: S\_LAURINDA\_LN Location: SE

ADA ID: RPRK220222195126 Ramp Type: Type 1 - Perpendicular Diagonal Initial Pass/Fail: Fail Overall Compliance: No Severity Score: 16

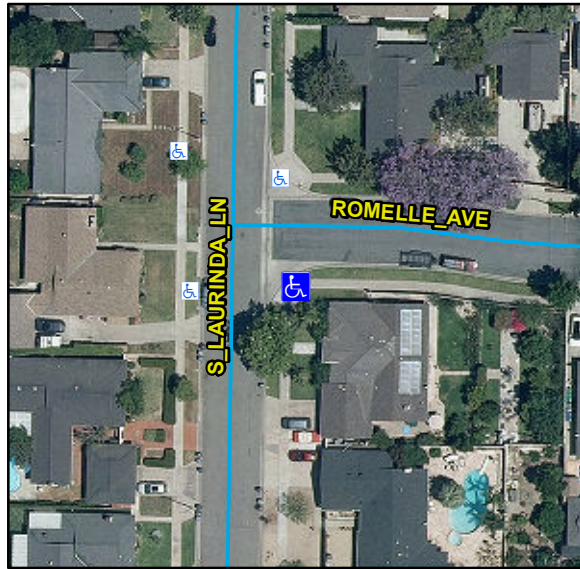
| Compliance | Description | Data | Compliance | Description | Data |
|---|---|---|---|---|---|
| No | Ramp Run Slope (%) | 8.9 | N/A | Flare Slope LT (%) | N/A |

Remove & Replace Curb Ramp With Two New Directional Ramps or Equivalent.

R304.2.2, STD 1115
