# Access Compliance Report Public Rights-of-Way (Curb Ramps)

Main Street: S\_PROSPECT\_ST Cross Street: E\_CASSELLE\_AVE Location: NE

ADA ID: RPRK220222200216 Ramp Type: Type 4 - Parallel Initial Pass/Fail: Fail Overall Compliance: No Severity Score: 2

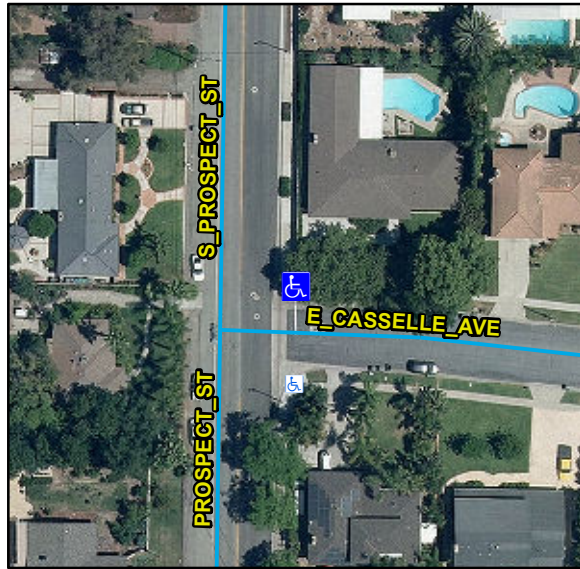
| Compliance | Description | Data | Compliance | Description | Data |
|---|---|---|---|---|---|
| Yes | Ramp Cross Slope LT (%) | 0.4 | No | Ramp Cross Slope RT (%) | 3 |

**Remove & Replace Curb Ramp With Two New Directional Ramps or Equivalent.**

**R304.5.3, STD 1115**
