# Access Compliance Report Public Rights-of-Way (Curb Ramps)

Main Street: DUNAS\_RD Cross Street: E\_DIXON\_AVE Location: SW

ADA ID: RPRK220222202019 Ramp Type: Type 1 - Perpendicular Diagonal Initial Pass/Fail: Fail Overall Compliance: No Severity Score: 16

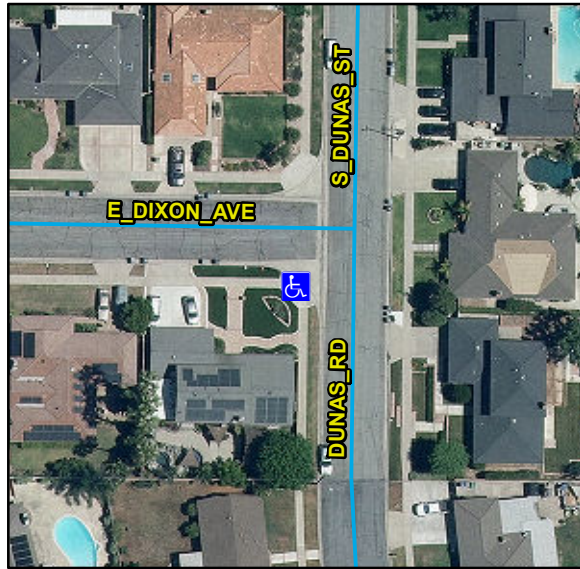
| Compliance | Description | Data | Compliance | Description | Data |
|---|---|---|---|---|---|
| No | Ramp Run Slope (%) | 8.9 | N/A | Flare Slope LT (%) | N/A |

Remove & Replace Curb Ramp With Two New Directional Ramps or Equivalent.

R304.2.2, STD 1115
