# Access Compliance Report Public Rights-of-Way (Curb Ramps)

Main Street: SWIDLER\_PL Cross Street: LA\_VETA\_AVE Location: SW

ADA ID: RPRK220222202841 Ramp Type: Type 1 - Perpendicular Diagonal Initial Pass/Fail: Fail Overall Compliance: No Severity Score: 2

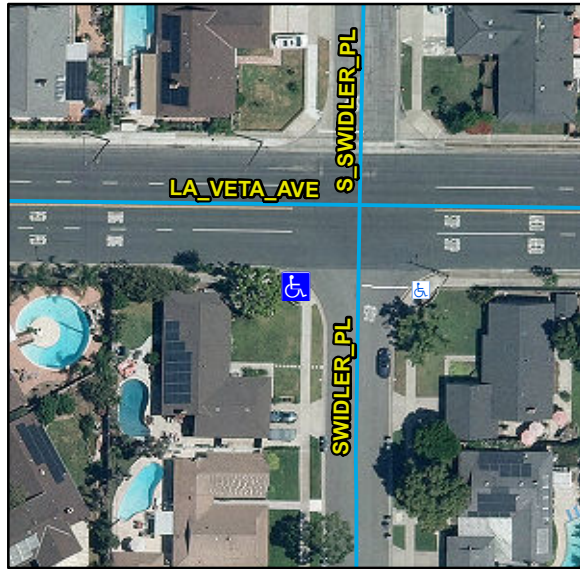
| Compliance | Description | Data | Compliance | Description | Data |
|---|---|---|---|---|---|
| No | Ramp Cross Slope (%) | 4.9 | N/A | Flare Traversable LT | N/A |

Remove & Replace Curb Ramp With Two New Directional Ramps or Equivalent.

R304.5.3, STD 1115
