# Access Compliance Report Public Rights-of-Way (Curb Ramps)

Main Street: CABARET\_CT Cross Street: FAIRHAVEN\_AVE Location: SW

ADA ID: RPRK220222205104 Ramp Type: Type 4 - Parallel Initial Pass/Fail: Fail Overall Compliance: No Severity Score: 16

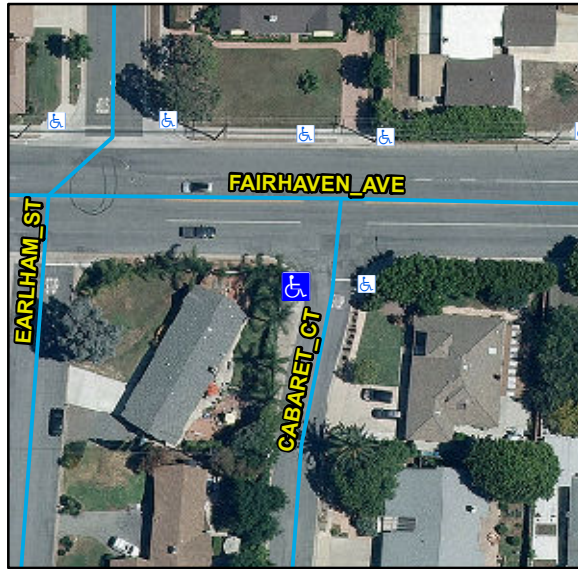
| Compliance | Description | Data | Compliance | Description | Data |
|---|---|---|---|---|---|
| Yes | Ramp Run Slope LT (%) | 3.7 | No | Ramp Run Slope RT (%) | 9 |
| No | Ramp Cross Slope LT (%) | 4.1 | Yes | Ramp Cross Slope RT (%) | 0.3 |

Remove & Replace Curb Ramp With Two New Directional Ramps or Equivalent.

R304.5.3, R304.3.2, STD 1115
