# Access Compliance Report Public Rights-of-Way (Curb Ramps)

Main Street: N/A Cross Street: ANTONIO\_PKWY Location: SW

ADA ID: RPRK220223135536 Ramp Type: Type 1 - Perpendicular Initial Pass/Fail: Pass Overall Compliance: No Severity Score: 15

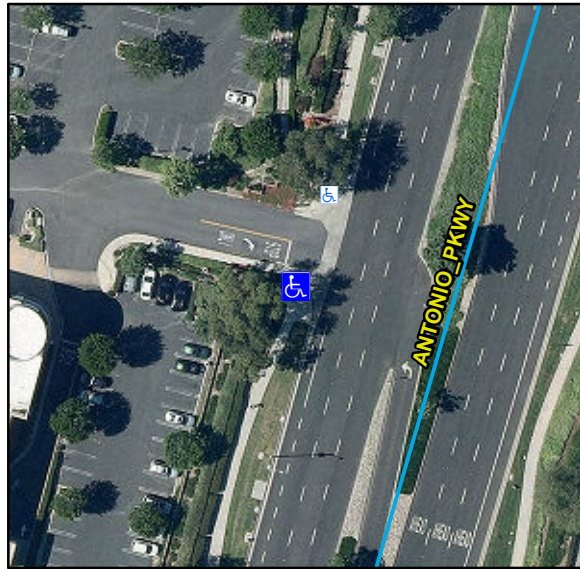
| Compliance | Description | Data | Compliance | Description | Data |
|---|---|---|---|---|---|
| Yes | Landing Cross Slope (%) | 0.5 | No | DWS Provided | No |
| No | Gutter Run Slope (%) | 9.9 | | Road Cross Slope (%) | 3.8 |

Remove & Replace Entire Ramp. Remove & Replace Gutter.

R304.2.1, R305, R304.5.4, STD 1115

Total Cost: \$ 3332
