# Access Compliance Report Public Rights-of-Way (Curb Ramps)

Main Street: N/A Cross Street: ANTONIO\_PKWY Location: NW

ADA ID: RPRK220223140034 Ramp Type: Type 1 - Perpendicular Initial Pass/Fail: Fail Overall Compliance: No Severity Score: 16

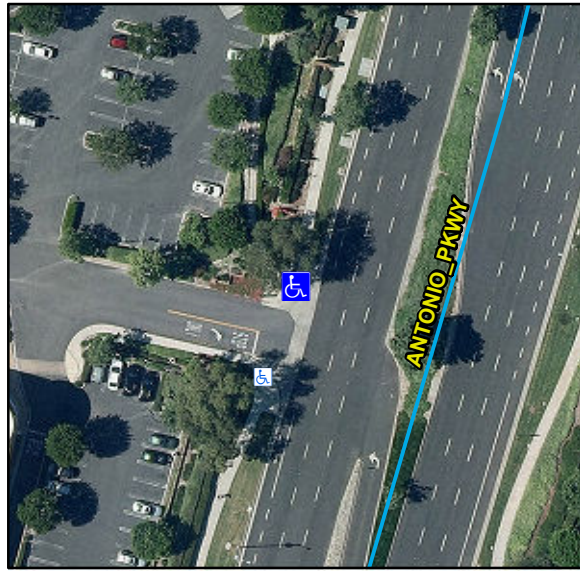
| Compliance | Description | Data | Compliance | Description | Data |
|---|---|---|---|---|---|
| No | Ramp Run Slope (%) | 8.9 | N/A | Flare Slope LT (%) | N/A |
| No | Ramp Cross Slope (%) | 2.3 | N/A | Flare Traversable LT | N/A |

Remove & Replace Entire Ramp.
