# Access Compliance Report Public Rights-of-Way (Curb Ramps)

Main Street: N/A Cross Street: ANTONIO\_PKWY Location: NW

ADA ID: RPRK220223140412 Ramp Type: Type 1 - Perpendicular Initial Pass/Fail: Fail Overall Compliance: No Severity Score: 2

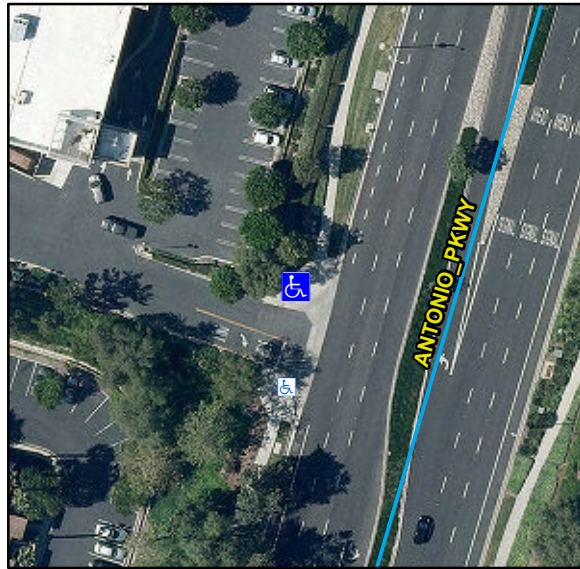
| Compliance | Description | Data | Compliance | Description | Data |
|---|---|---|---|---|---|
| No | Ramp Cross Slope (%) | 2.2 | N/A | Flare Traversable LT | N/A |

Remove & Replace Entire Ramp.

R304.5.3, STD 1115
