# Access Compliance Report Public Rights-of-Way (Curb Ramps)

Main Street: N/A Cross Street: ANTONIO\_PKWY Location: SW

ADA ID: RPRK220223140635 Ramp Type: Type 1 - Perpendicular Initial Pass/Fail: Pass Overall Compliance: No Severity Score: 10

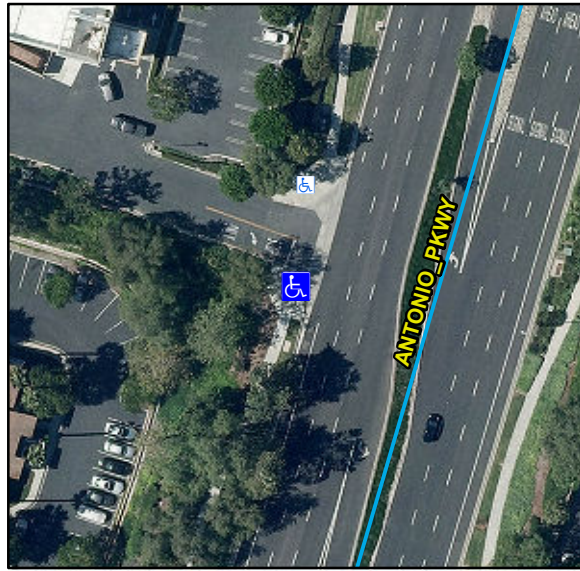
| Compliance | Description | Data | Compliance | Description | Data |
|---|---|---|---|---|---|
| Yes | Landing Cross Slope (%) | 0.4 | No | DWS Provided | No |

Possible Solutions:

Install Detectable Warning System.
