# Access Compliance Report Public Rights-of-Way (Curb Ramps)

Main Street: MAIN\_ST Cross Street: N/A Location: SW

ADA ID: RPRK220223141614 Ramp Type: Type 4 - Parallel Initial Pass/Fail: Fail Overall Compliance: No Severity Score: 45

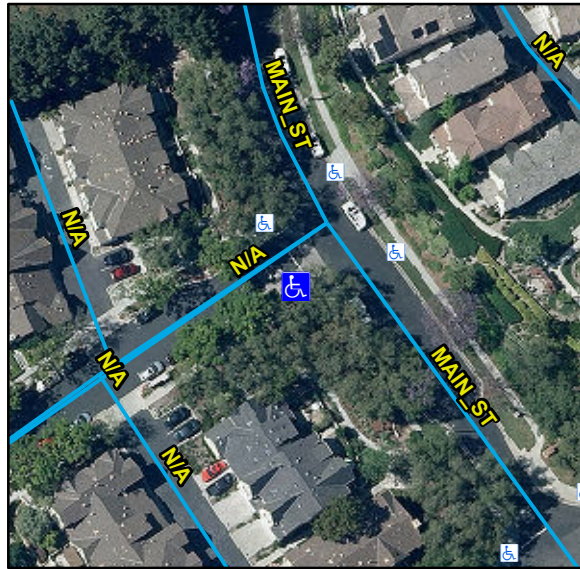
| Compliance | Description | Data | Compliance | Description | Data |
|---|---|---|---|---|---|
| Yes | Ramp Run Slope LT (%) | 3.8 | No | Ramp Run Slope RT (%) | 10.2 |
| No | Ramp Cross Slope LT (%) | 5.9 | No | Ramp Cross Slope RT (%) | 7.4 |

Remove & Replace Curb Ramp With Two New Directional Ramps or Equivalent.

R304.5.3, R304.3.2, STD 1115

Total Cost: \$ 4000
