# Access Compliance Report Public Rights-of-Way (Curb Ramps)

Main Street: N/A Cross Street: MAIN\_ST Location: NW

ADA ID: RPRK220223142016 Ramp Type: Type 4 - Parallel Initial Pass/Fail: Fail Overall Compliance: No Severity Score: 16

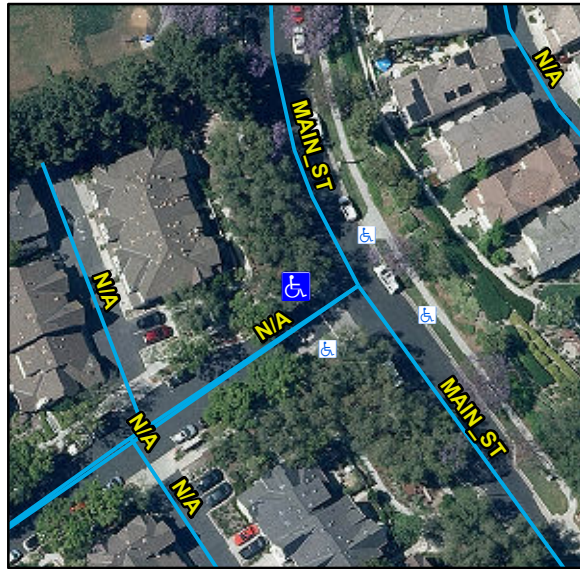
| Compliance | Description | Data | Compliance | Description | Data |
|---|---|---|---|---|---|
| Yes | Ramp Run Slope LT (%) | 2.1 | No | Ramp Run Slope RT (%) | 10.4 |
| No | Ramp Cross Slope LT (%) | 4.2 | No | Ramp Cross Slope RT (%) | 2.6 |

Remove & Replace Curb Ramp With Two New Directional Ramps or Equivalent.

R304.5.3, R304.3.2, STD 1115

\$ 4000
