# Access Compliance Report Public Rights-of-Way (Curb Ramps)

Main Street: THIRD\_RD Cross Street: N/A Location: SW

ADA ID: RPRK220223143035 Ramp Type: Type 4 - Parallel Initial Pass/Fail: Fail Overall Compliance: No Severity Score: 15

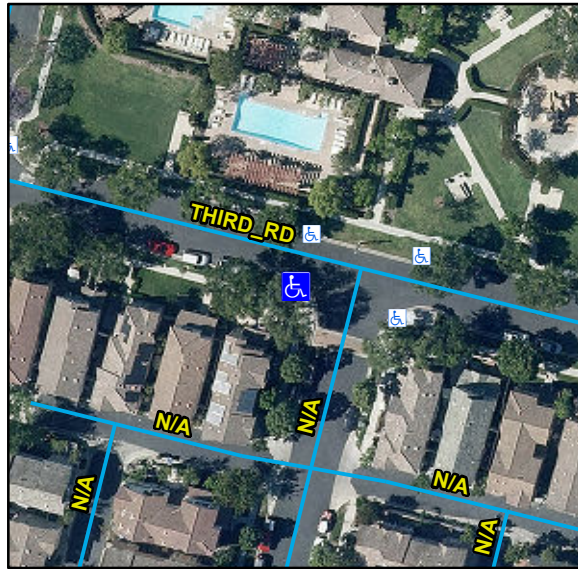
| Compliance | Description | Data | Compliance | Description | Data |
|---|---|---|---|---|---|
| No | Ramp Cross Slope LT (%) | 5.1 | No | Ramp Cross Slope RT (%) | 6 |

Remove & Replace Curb Ramp With Two New Directional Ramps or Equivalent.

R304.5.3, STD 1115

\$ 4000
