# Access Compliance Report Public Rights-of-Way (Curb Ramps)

Main Street: THIRD\_RD Cross Street: PAVERSTONE Location: SE

ADA ID: RPRK220223143428 Ramp Type: Type 4 - Parallel Initial Pass/Fail: Fail Overall Compliance: No Severity Score: 15

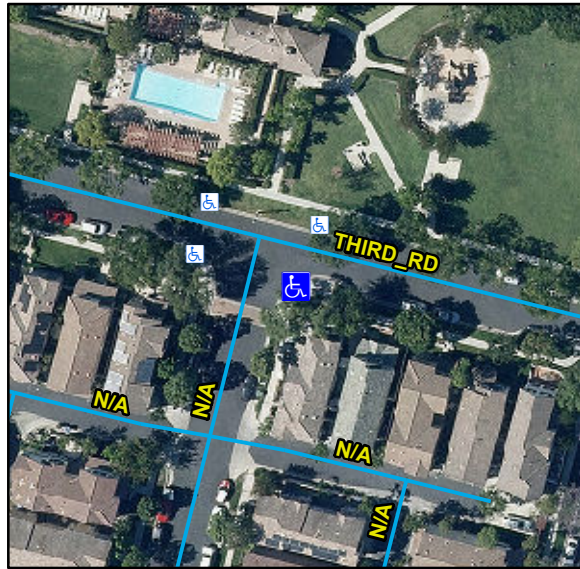
| Compliance | Description | Data | Compliance | Description | Data |
|---|---|---|---|---|---|
| No | Ramp Cross Slope LT (%) | 6 | No | Ramp Cross Slope RT (%) | 4 |

Remove & Replace Curb Ramp With Two New Directional Ramps or Equivalent.

R304.5.3, STD 1115

Total Cost: \$ 4000
