# Access Compliance Report Public Rights-of-Way (Curb Ramps)

| Main Street: SKLAR_ST | | Cross Street: IRISH_MOSS_ST | | Location: | W |
| ADA ID: RPRK220223144507 | Ramp Type: Type 4 - Parallel | Initial Pass/Fail: Fail | Overall Compliance: No | Severity Score: | 2 |

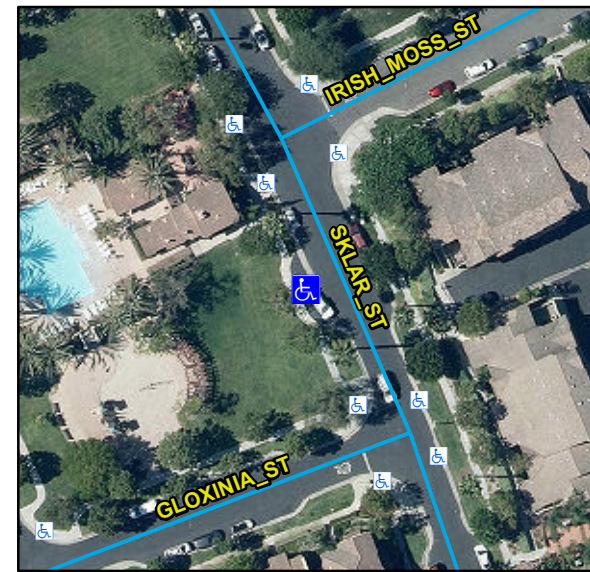
| Compliance | Description | Data | Compliance | Description | Data |
|---|---|---|---|---|---|
| No | Ramp Cross Slope LT (%) | 3.5 | No | Ramp Cross Slope RT (%) | 2.7 |

Remove & Replace Entire Ramp.

R304.5.3, STD 1115

Total Cost: \$ 2000
