# Access Compliance Report Public Rights-of-Way (Curb Ramps)

| Main Street: STRAWFLOWER_ST | | Cross Street: ABELIA_ST | | Location: | E |
| ADA ID: RPRK220223145051 | Ramp Type: Type 4 - Parallel | Initial Pass/Fail: Fail | Overall Compliance: No | Severity Score: | 2 |

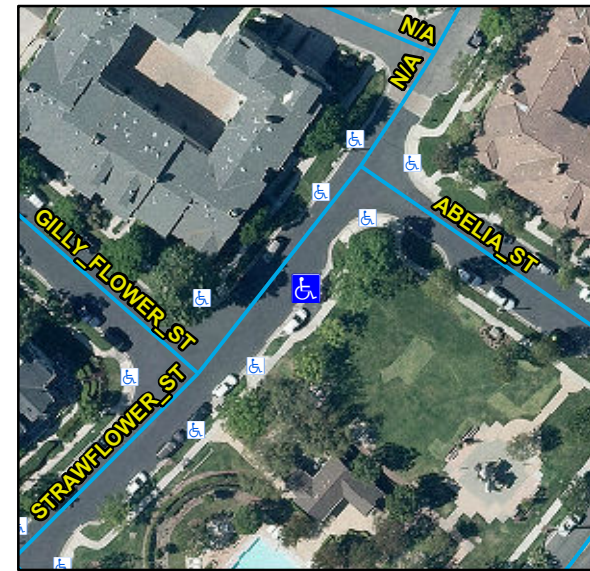
| Compliance | Description | Data | Compliance | Description | Data |
|---|---|---|---|---|---|
| No | Ramp Cross Slope LT (%) | 2.7 | Yes | Ramp Cross Slope RT (%) | 1.9 |

Possible Solutions:

Remove & Replace Entire Ramp.

R304.5.3, STD 1115

Total Cost: \$ 2000
