# Access Compliance Report Public Rights-of-Way (Curb Ramps)

| Main Street: N/A | | Cross Street: DORRANCE_DR | | Location: | NE |
| ADA ID: RPRK220223150055 | Ramp Type: Type 4 - Parallel | Initial Pass/Fail: Fail | Overall Compliance: No | Severity Score: | 16 |

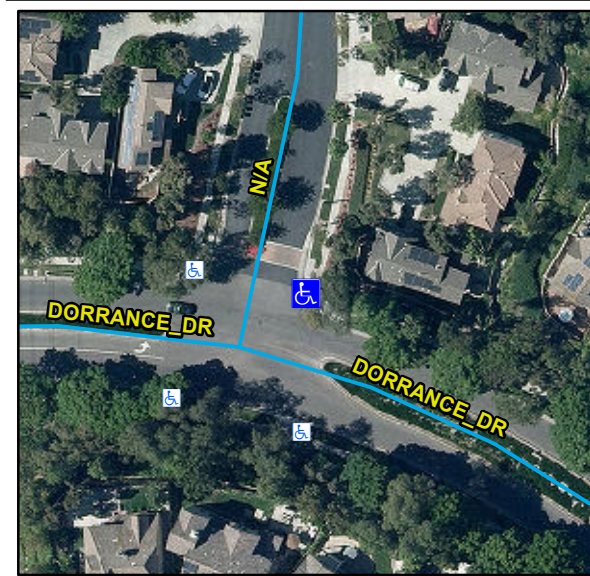
| Compliance | Description | Data | Compliance | Description | Data |
|---|---|---|---|---|---|
| Yes | Ramp Run Slope LT (%) | 1.3 | No | Ramp Run Slope RT (%) | 9.3 |
| No | Ramp Cross Slope LT (%) | 3.3 | Yes | Ramp Cross Slope RT (%) | 0.5 |

**Remove & Replace Curb Ramp With Two New Directional Ramps or Equivalent.**

**R304.5.3, R304.3.2, STD 1115**
