# Access Compliance Report Public Rights-of-Way (Curb Ramps)

| Main Street: DORRANCE_DR | | Cross Street: N/A | | Location: | NW |
| ADA ID: RPRK220223150827 | Ramp Type: Type 4 - Parallel | Initial Pass/Fail: Fail | Overall Compliance: No | Severity Score: | 15 |

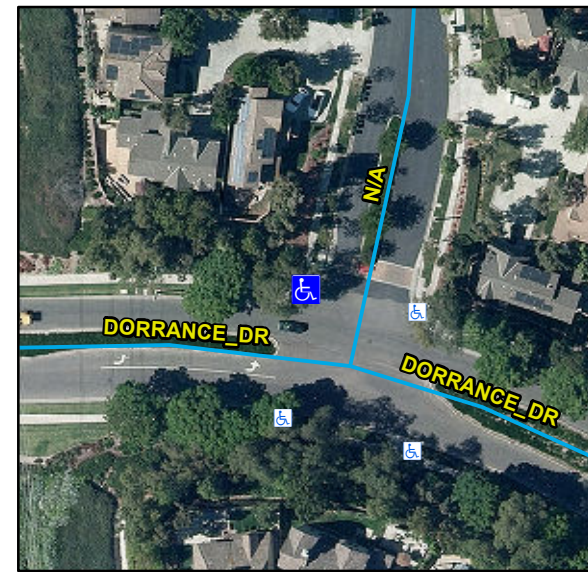
| Compliance | Description | Data | Compliance | Description | Data |
|---|---|---|---|---|---|
| Yes | Ramp Run Slope LT (%) | 1.5 | No | Ramp Run Slope RT (%) | 9.4 |

Possible Solutions:

**Remove & Replace Curb Ramp With Two New Directional Ramps or Equivalent.**

**R304.3.2, STD 1115**

Total Cost: \$ 4000

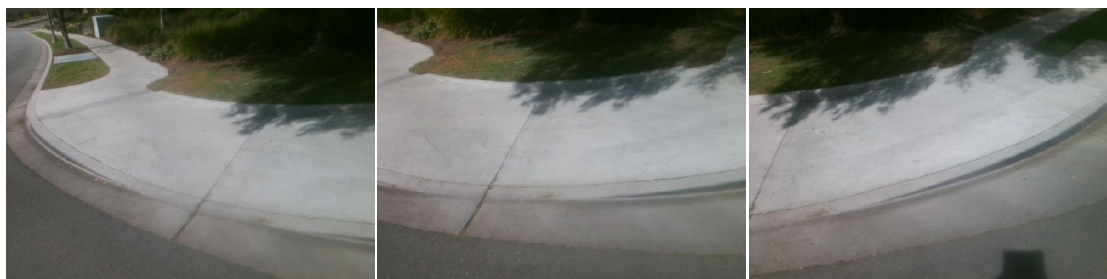
| Compliance | Description | Data | Compliance | Description | Data |
|---|---|---|---|---|---|
| N/A | Ramp Length LT (in) | 132 | N/A | Ramp Length RT (in) | 132 |
| Yes | Ramp Width LT (in) | 90 | Yes | Ramp Width RT (in) | 90 |
| Yes | Ramp Cross Slope LT (%) | 1.7 | Yes | Ramp Cross Slope RT (%) | 1.6 |
