# Access Compliance Report Public Rights-of-Way (Curb Ramps)

Main Street: UNIVERSITY\_AVE Cross Street: WOODBRIAR Location: SW

ADA ID: RPRK220223151756 Ramp Type: Type 4 - Parallel Initial Pass/Fail: Fail Overall Compliance: No Severity Score: 16

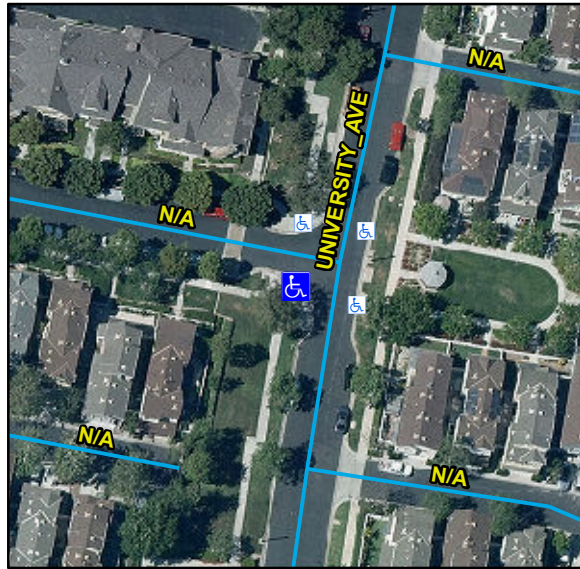
| Compliance | Description | Data | Compliance | Description | Data |
|---|---|---|---|---|---|
| No | Ramp Run Slope LT (%) | 10 | Yes | Ramp Run Slope RT (%) | 0.1 |
| No | Ramp Cross Slope LT (%) | 2.3 | Yes | Ramp Cross Slope RT (%) | 1.5 |

Remove & Replace Curb Ramp With Two New Directional Ramps or Equivalent.

R304.3.2, R304.5.3, STD 1115

Total Cost: \$ 4000
