# Access Compliance Report Public Rights-of-Way (Curb Ramps)

Main Street: FARMHOUSE Cross Street: UNIVERSITY\_AVE Location: NW

ADA ID: RPRK220223163110 Ramp Type: Type 4 - Parallel Initial Pass/Fail: Fail Overall Compliance: No Severity Score: 2

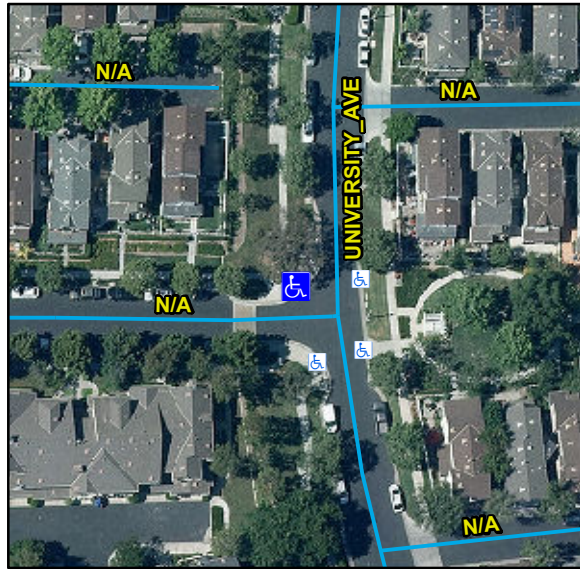
| Compliance | Description | Data | Compliance | Description | Data |
|---|---|---|---|---|---|
| No | Ramp Cross Slope LT (%) | 2.5 | Yes | Ramp Cross Slope RT (%) | 0.9 |

**Remove & Replace Curb Ramp With Two New Directional Ramps or Equivalent.**

**R304.5.3, STD 1115**

Total Cost: \$ 4000
