# Access Compliance Report Public Rights-of-Way (Curb Ramps)

Main Street: UNIVERSITY\_AVE Cross Street: FARMHOUSE Location: SE

ADA ID: RPRK220223163449 Ramp Type: Type 1 - Perpendicular Initial Pass/Fail: Pass Overall Compliance: No Severity Score: 16

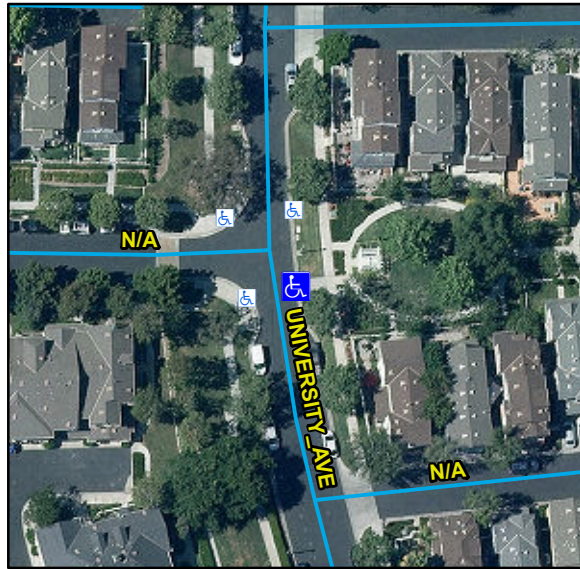
| Compliance | Description | Data | Compliance | Description | Data |
|---|---|---|---|---|---|
| Yes | Landing Cross Slope (%) | 1 | No | DWS Provided | No |
| No | Gutter Run Slope (%) | 13.2 | | Road Cross Slope (%) | N/A |

Install Detectable Warning System. Remove & Replace Gutter.

R305, R304.5.4, STD 1115
