# Access Compliance Report Public Rights-of-Way (Curb Ramps)

Main Street: N/A Cross Street: O\_NEILL\_DR Location: W

ADA ID: RPRK220223165435 Ramp Type: Type 6 - Directional 1 Initial Pass/Fail: Fail Overall Compliance: No Severity Score: 2

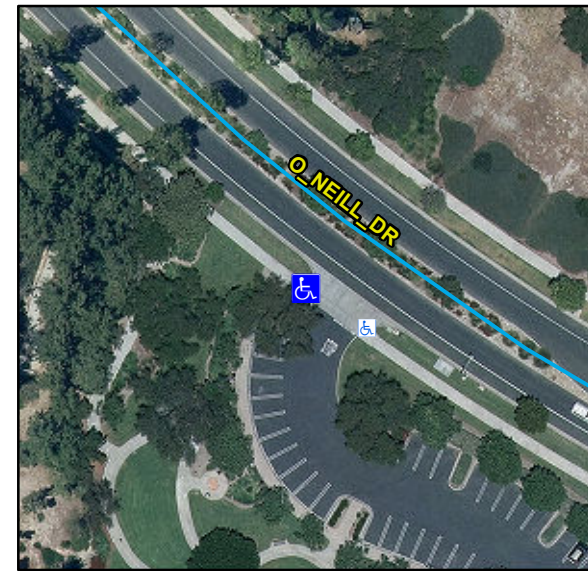
| Compliance | Description | Data | Compliance | Description | Data |
|---|---|---|---|---|---|
| No | Ramp Cross Slope (%) | 5 | N/A | Flare Traversable LT | N/A |

Possible Solutions:

Remove & Replace Entire Ramp.

R304.5.3, STD 1115
