# Access Compliance Report Public Rights-of-Way (Curb Ramps)

Main Street: N/A Cross Street: O\_NEILL\_DR Location: SE

ADA ID: RPRK220223165650 Ramp Type: Type 6 - Directional 1 Initial Pass/Fail: Pass Overall Compliance: No Severity Score: 15

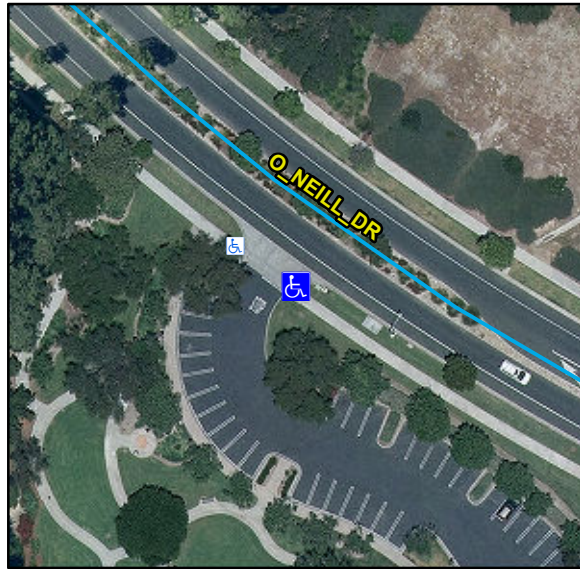
| Compliance | Description | Data | Compliance | Description | Data |
|---|---|---|---|---|---|
| No | Grade Break | No | Yes | Flare Type RT | |
| | Addl Para Ramp Right? | No | No | DWS Provided | No |
| No | Landing Cross Slope (%) | 2.8 | N/A | DWS Left Offset (in) | N/A |
| No | Gutter Run Slope (%) | 6.3 | | Road Cross Slope (%) | N/A |
| No | Gutter Cross Slope (%) | 4.9 | | Parallel Ramp Side | N/A |

Remove & Replace Entire Ramp. Remove & Replace Gutter.

R304.5.3, R304.5.2, R305, R304.5.4, STD 1115

Total Cost: \$ 3332
