# Access Compliance Report Public Rights-of-Way (Curb Ramps)

Main Street: N/A Cross Street: O\_NEILL\_DR Location: SW

ADA ID: RPRK220223170144 Ramp Type: Type 6 - Directional 1 Initial Pass/Fail: Fail Overall Compliance: No Severity Score: 2

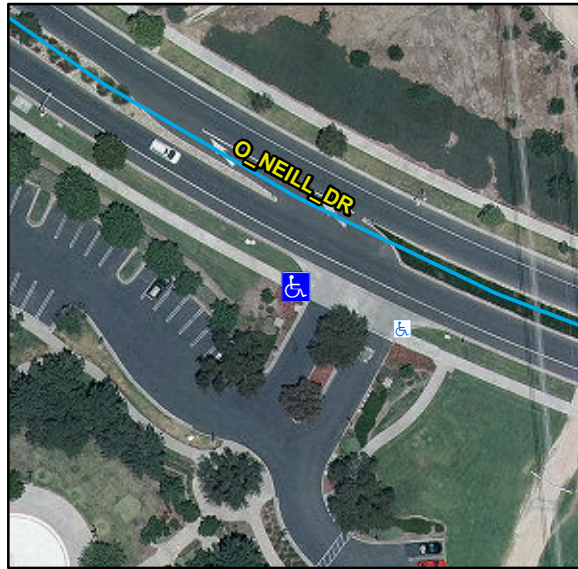
| Compliance | Description | Data | Compliance | Description | Data |
|---|---|---|---|---|---|
| No | Ramp Cross Slope (%) | 2.2 | N/A | Flare Traversable LT | N/A |

Remove & Replace Entire Ramp.

R304.5.3, STD 1115

\$ 3080
