# Access Compliance Report Public Rights-of-Way (Curb Ramps)

Main Street: N/A Cross Street: O\_NEILL\_DR Location: SE

ADA ID: RPRK220223170341 Ramp Type: Type 6 - Directional 1 Initial Pass/Fail: Pass Overall Compliance: No Severity Score: 10

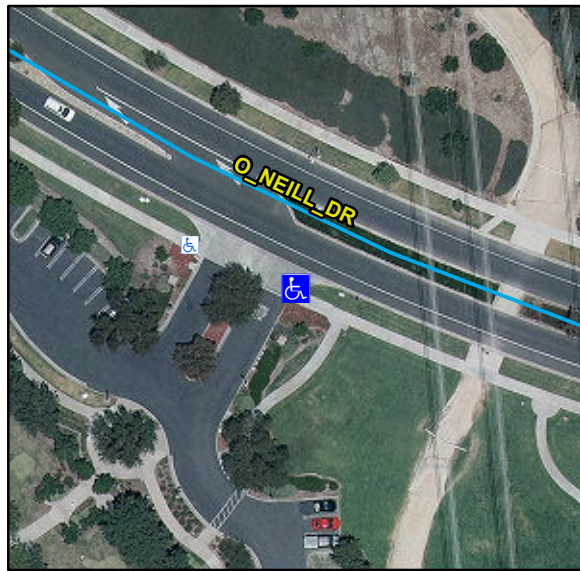
| Compliance | Description | Data | Compliance | Description | Data |
|---|---|---|---|---|---|
| No | Grade Break | No | Yes | Flare Type RT | |
| | Addl Para Ramp Right? | No | No | DWS Provided | No |

Remove & Replace Entire Ramp.
