# Access Compliance Report Public Rights-of-Way (Curb Ramps)

Main Street: COVENANT\_HILLS\_DR Cross Street: SIENNA\_PKWY Location: SE

ADA ID: RPRK220223171301 Ramp Type: Type 4 - Parallel Initial Pass/Fail: Fail Overall Compliance: No Severity Score: 2

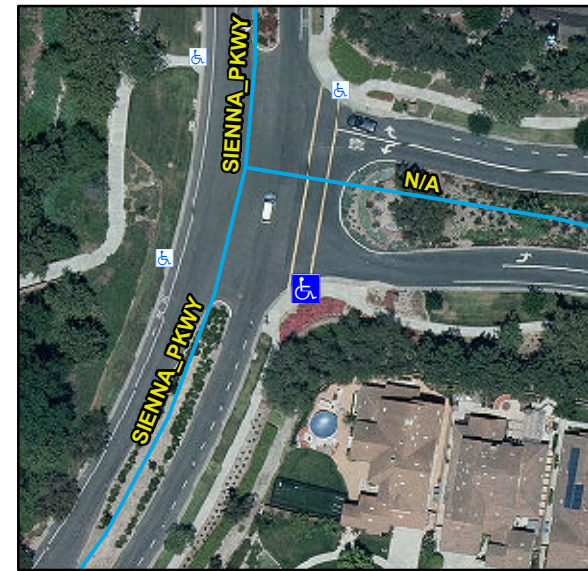
| Compliance | Description | Data | Compliance | Description | Data |
|---|---|---|---|---|---|
| No | Ramp Cross Slope LT (%) | 2.8 | No | Ramp Cross Slope RT (%) | 2.6 |

Remove & Replace Curb Ramp With Two New Directional Ramps or Equivalent. Restripe Crosswalk.

R304.5.3, STD 1115

Total Cost: \$ 8000
