# Access Compliance Report Public Rights-of-Way (Curb Ramps)

Main Street: SIENNA\_PKWY Cross Street: COVENANT\_HILLS\_DR Location: NE

ADA ID: RPRK220223171809 Ramp Type: Type 4 - Parallel Initial Pass/Fail: Fail Overall Compliance: No Severity Score: 2

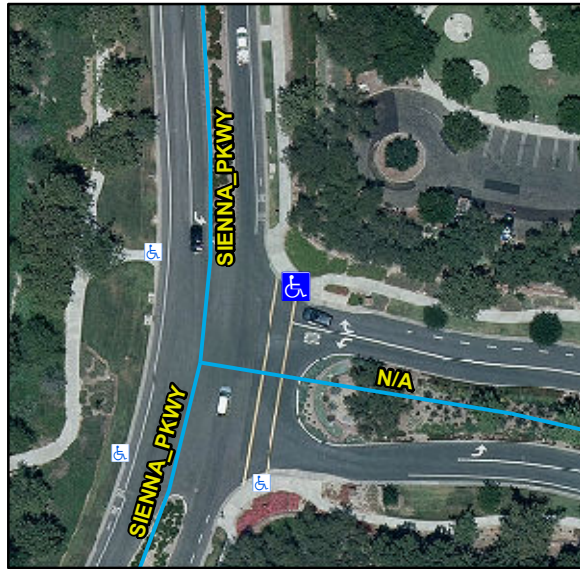
| Compliance | Description | Data | Compliance | Description | Data |
|---|---|---|---|---|---|
| N/A | Ramp Length LT (in) | 128 | N/A | Ramp Length RT (in) | 135 |
| Yes | Ramp Width LT (in) | 89 | Yes | Ramp Width RT (in) | 89 |
| Yes | Ramp Run Slope LT (%) | 6.8 | Yes | Ramp Run Slope RT (%) | 2.4 |
| No | Ramp Cross Slope LT (%) | 3.8 | No | Ramp Cross Slope RT (%) | 2.1 |

Remove & Replace Curb Ramp With Two New Directional Ramps or Equivalent. Restripe Crosswalk.

R304.5.3, STD 1115

Total Cost: \$ 8000
