| Main Street: SIENNA_PKWY | | Cross Street: COVENANT_HILLS_DR | | Location: | NW |

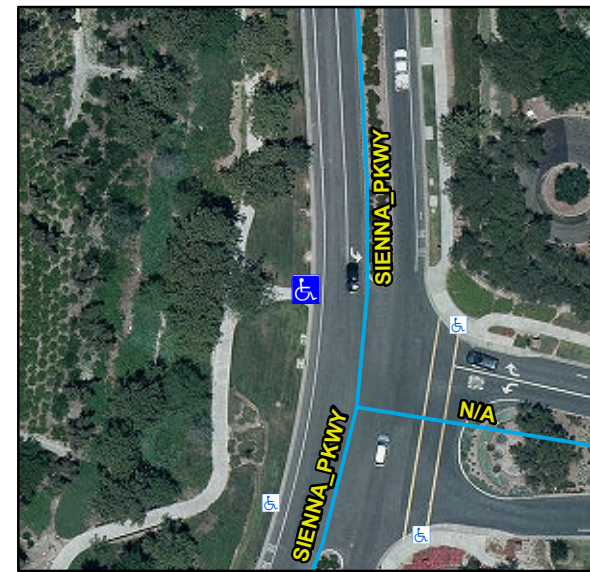
| ADA ID: RPRK220223172150 | Ramp Type: Type 1 - Perpendicular | Initial Pass/Fail: Fail | Overall Compliance: No | Severity Score: | 15 |

R304.2.2, STD 1115

| Compliance | Description | Data | Compliance | Description | Data |
|---|---|---|---|---|---|
| No | Ramp Run Slope (%) | 8.6 | N/A | Flare Slope LT (%) | N/A |

Remove & Replace Entire Ramp.

Total Cost: \$ 3080
