# Access Compliance Report Public Rights-of-Way (Curb Ramps)

Main Street: N/A Cross Street: SIENNA\_PKWY Location: SW

ADA ID: RPRK220223172630 Ramp Type: Type 6 - Directional 1 Initial Pass/Fail: Pass Overall Compliance: No Severity Score: 15

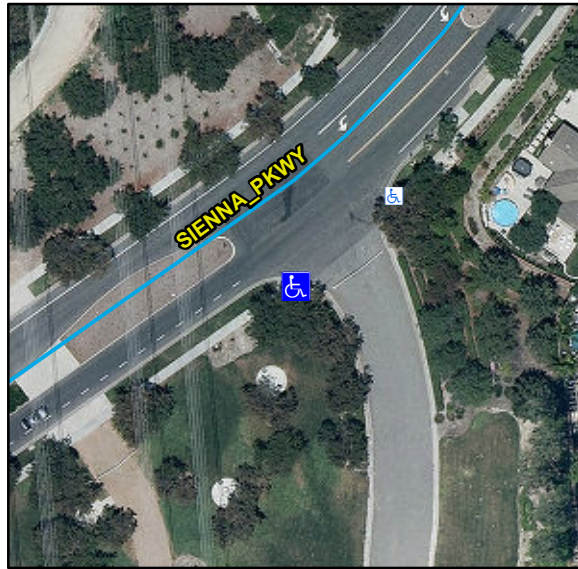
| Compliance | Description | Data | Compliance | Description | Data |
|---|---|---|---|---|---|
| No | Grade Break | No | N/A | Flare Type RT | |
| | Addl Para Ramp Right? | No | No | DWS Provided | No |
| No | Gutter Run Slope (%) | 8.2 | | Road Cross Slope (%) | N/A |

Remove & Replace Entire Ramp. Remove & Replace Gutter.

R304.5.2, R305, R304.5.4, STD 1115
