# Access Compliance Report Public Rights-of-Way (Curb Ramps)

Main Street: N/A Cross Street: SIENNA\_PKWY Location: SE

ADA ID: RPRK220223173243 Ramp Type: Type 6 - Directional 1 Initial Pass/Fail: Pass Overall Compliance: No Severity Score: 15

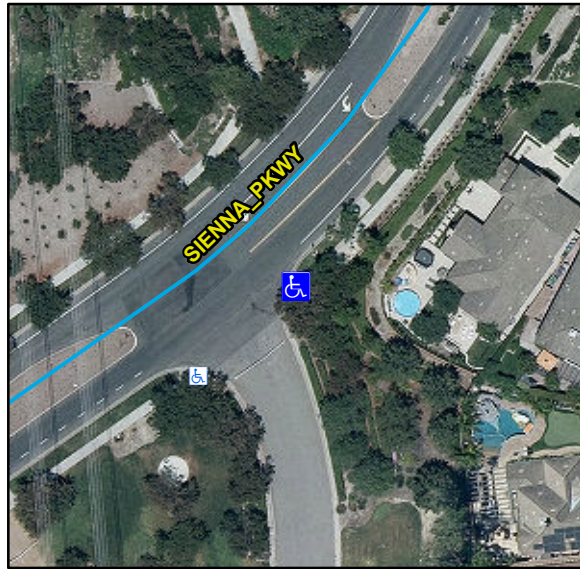
| Compliance | Description | Data | Compliance | Description | Data |
|---|---|---|---|---|---|
| No | Grade Break | No | Yes | Flare Type RT | |
| No | Gutter Ponding | Yes | Yes | Curb Slope | 1.6 |
| No | Gutter Run Slope (%) | 9.3 | | Road Cross Slope (%) | N/A |

Remove & Replace Entire Ramp. Remove & Replace Gutter.

R304.5.2, R305, R302.7, R304.5.4, STD 1115
