# Access Compliance Report Public Rights-of-Way (Curb Ramps)

Main Street: SIENNA\_PKWY Cross Street: N/A Location: SE

ADA ID: RPRK220223173845 Ramp Type: Type 4 - Parallel Initial Pass/Fail: Fail Overall Compliance: No Severity Score: 16

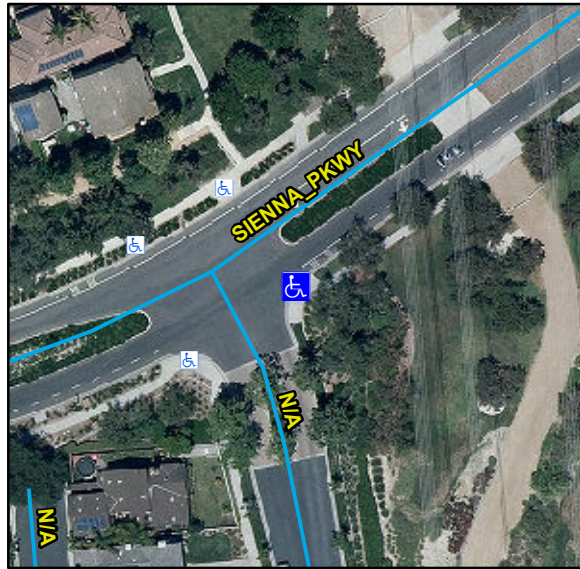
| Compliance | Description | Data | Compliance | Description | Data |
|---|---|---|---|---|---|
| No | Ramp Run Slope LT (%) | 9.7 | Yes | Ramp Run Slope RT (%) | 0.4 |
| No | Ramp Cross Slope LT (%) | 4.6 | Yes | Ramp Cross Slope RT (%) | 2 |

**Remove & Replace Curb Ramp With Two New Directional Ramps or Equivalent.**

**R304.3.2, R304.5.3, STD 1115**

Total Cost: \$ 4000
