# Access Compliance Report Public Rights-of-Way (Curb Ramps)

Main Street: N/A Cross Street: SIENNA\_PKWY Location: N

ADA ID: RPRK220223174523 Ramp Type: Type 4 - Parallel Initial Pass/Fail: Fail Overall Compliance: No Severity Score: 15

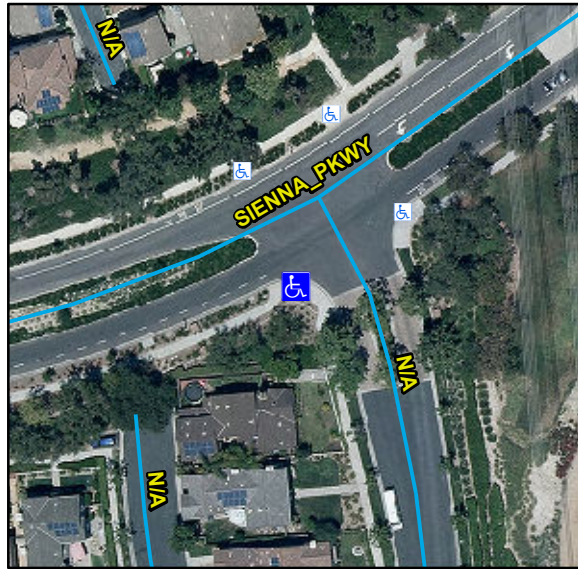
| Compliance | Description | Data | Compliance | Description | Data |
|---|---|---|---|---|---|
| No | Ramp Run Slope LT (%) | 9.2 | Yes | Ramp Run Slope RT (%) | 0.2 |

**Remove & Replace Curb Ramp With Two New Directional Ramps or Equivalent.**

**R304.3.2, STD 1115**

Total Cost: \$ 4000
