# Access Compliance Report Public Rights-of-Way (Curb Ramps)

Main Street: PUESTO\_DR Cross Street: N/A Location: SE

ADA ID: RPRK220223184213 Ramp Type: Type 1 - Perpendicular Initial Pass/Fail: Fail Overall Compliance: No Severity Score: 16

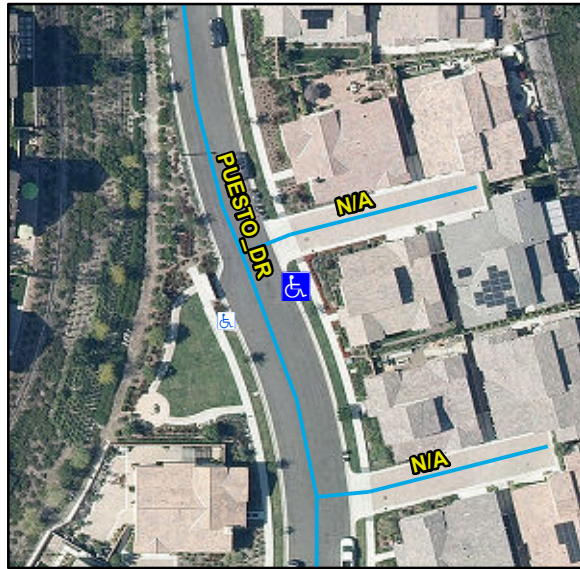
| Compliance | Description | Data | Compliance | Description | Data |
|---|---|---|---|---|---|
| No | Ramp Run Slope (%) | 8.8 | N/A | Flare Slope LT (%) | N/A |
| No | Ramp Cross Slope (%) | 2.1 | N/A | Flare Traversable LT | N/A |

Remove & Replace Entire Ramp.

R304.2.2, R304.5.3, STD 1115
