# Access Compliance Report Public Rights-of-Way (Curb Ramps)

Main Street: PUESTO\_DR Cross Street: N/A Location: SW

ADA ID: RPRK220223184352 Ramp Type: Type 1 - Perpendicular Initial Pass/Fail: Pass Overall Compliance: No Severity Score: 4

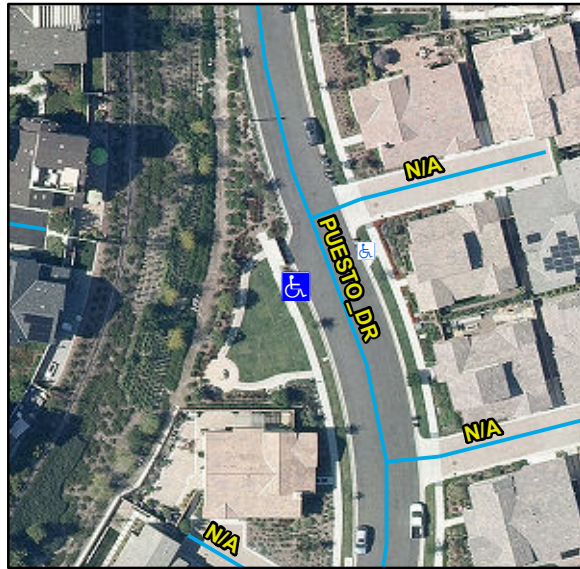
| Compliance | Description | Data | Compliance | Description | Data |
|---|---|---|---|---|---|
| N/A | Landing Length (in) | 47 | | | Sloped |
| N/A | Landing Movement Obstructed? | Yes | Yes | DWS Contrast | Yes |
| | Landing Movement Type | Curb | Yes | DWS Length (in) | 36 |

Remove & Replace Landing.

R304.2.1, STD 1115

\$ 531
