# Access Compliance Report Public Rights-of-Way (Curb Ramps)

Main Street: S\_ROSEBAY\_ST Cross Street: BROADWAY Location: SW

ADA ID: RPRK220224153442 Ramp Type: Type 3 - Combination 1 Initial Pass/Fail: Fail Overall Compliance: No Severity Score: 2

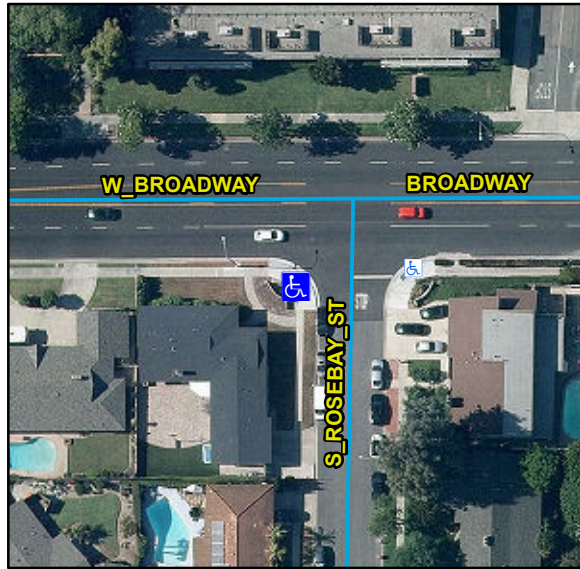
| Compliance | Description | Data | Compliance | Description | Data |
|---|---|---|---|---|---|
| No | Ramp Cross Slope LT (%) | 4.3 | No | Ramp Cross Slope RT (%) | 4.8 |

Remove & Replace Curb Ramp With Two New Directional Ramps or Equivalent.

R304.5.3, STD 1115
