# Access Compliance Report Public Rights-of-Way (Curb Ramps)

Main Street: BROADWAY Cross Street: S\_ROSEBAY\_ST Location: SE

ADA ID: RPRK220224154037 Ramp Type: Type 3 - Combination 1 Initial Pass/Fail: Fail Overall Compliance: No Severity Score: 2

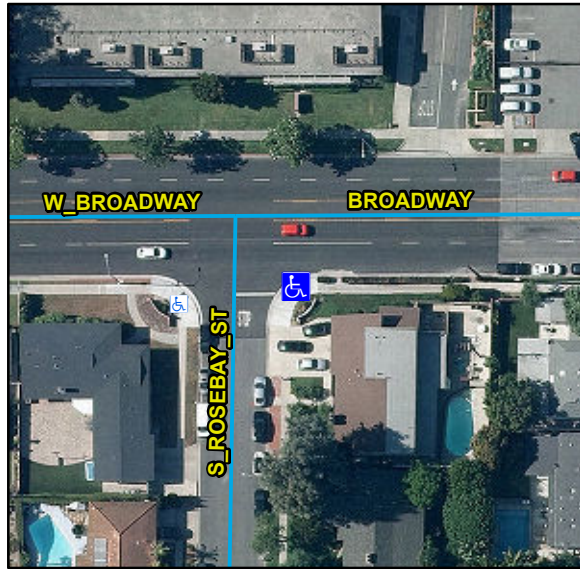
| Compliance | Description | Data | Compliance | Description | Data |
|---|---|---|---|---|---|
| No | Ramp Cross Slope LT (%) | 4.3 | No | Ramp Cross Slope RT (%) | 4.3 |

Remove & Replace Curb Ramp With Two New Directional Ramps or Equivalent.

R304.5.3, STD 1115
