# Access Compliance Report Public Rights-of-Way (Curb Ramps)

Main Street: PUERTO\_PL Cross Street: PUERTO\_PL Location: NW

ADA ID: RPRK220224192313 Ramp Type: Type 3 - Combination 1 Initial Pass/Fail: Fail Overall Compliance: No Severity Score: 32

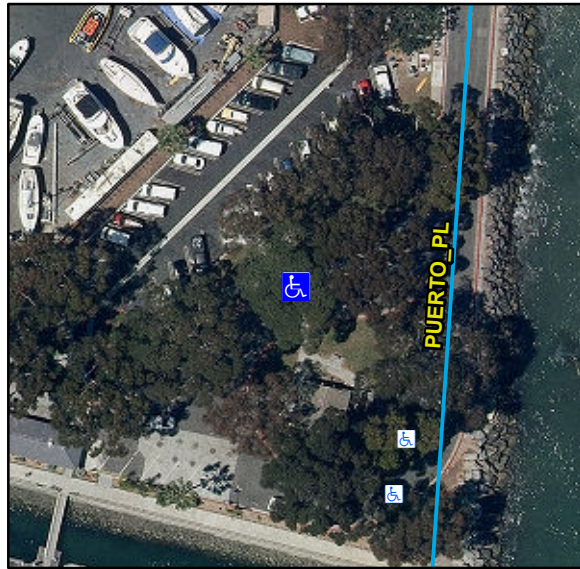
| Compliance | Description | Data | Compliance | Description | Data |
|---|---|---|---|---|---|
| No | Ramp Cross Slope LT (%) | 4.2 | No | Ramp Cross Slope RT (%) | 4.2 |
| No | Ramp Run Slope (%) | 12.9 | N/A | Flare Slope LT (%) | N/A |

Remove & Replace Entire Ramp.

Total Cost: \$ 3080
