# Access Compliance Report Public Rights-of-Way (Curb Ramps)

Main Street: OAKTREE Cross Street: OAKTREE Location: SE

ADA ID: RPRK220225180658 Ramp Type: Type 4 - Parallel Initial Pass/Fail: Fail Overall Compliance: No Severity Score: 45

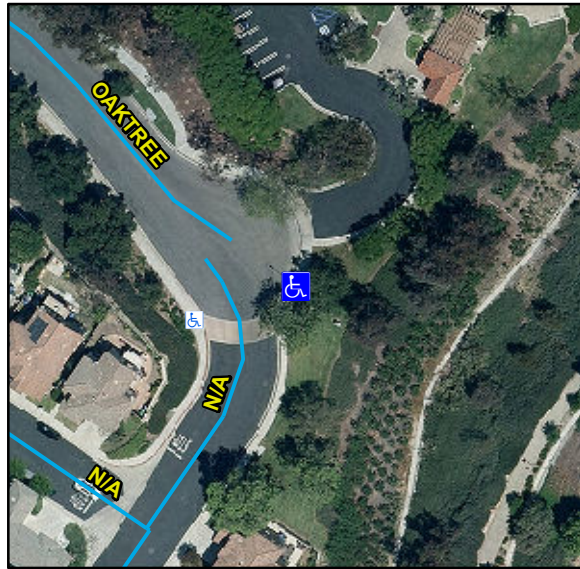
| Compliance | Description | Data | Compliance | Description | Data |
|---|---|---|---|---|---|
| Yes | Ramp Run Slope LT (%) | 3.8 | No | Ramp Run Slope RT (%) | 16.6 |
| No | Ramp Cross Slope LT (%) | 5.5 | Yes | Ramp Cross Slope RT (%) | 1.9 |

Remove & Replace Entire Ramp.
