# Access Compliance Report Public Rights-of-Way (Curb Ramps)

Main Street: OAKTREE Cross Street: OAKTREE Location: SW

ADA ID: RPRK220225181153 Ramp Type: Type 4 - Parallel Initial Pass/Fail: Fail Overall Compliance: No Severity Score: 32

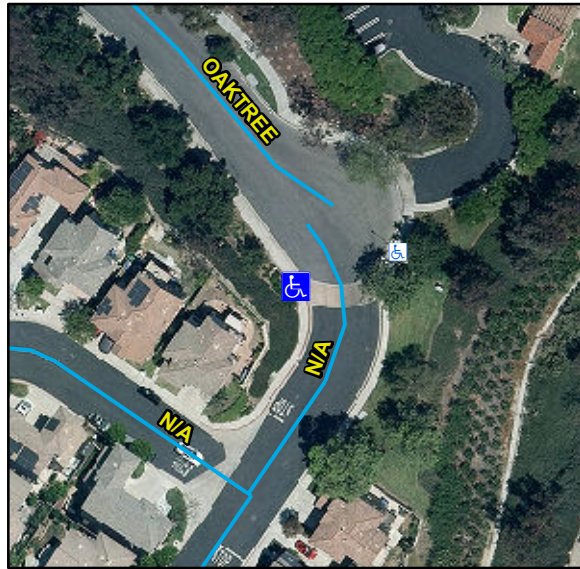
| Compliance | Description | Data | Compliance | Description | Data |
|---|---|---|---|---|---|
| No | Ramp Run Slope LT (%) | 19.8 | Yes | Ramp Run Slope RT (%) | 0.5 |
| Yes | Ramp Cross Slope LT (%) | 1.6 | No | Ramp Cross Slope RT (%) | 2.9 |

Remove & Replace Entire Ramp.

R304.3.2, R304.5.3, STD 1115

\$ 2000
