# Access Compliance Report Public Rights-of-Way (Curb Ramps)

| Main Street: DORRANCE_DR | | Cross Street: N/A | | Location: | SE |
| ADA ID: RPRK220225190227 | Ramp Type:Type 1 - Perpendicular | Initial Pass/Fail: Fail | Overall Compliance: No | Severity Score: | 30 |

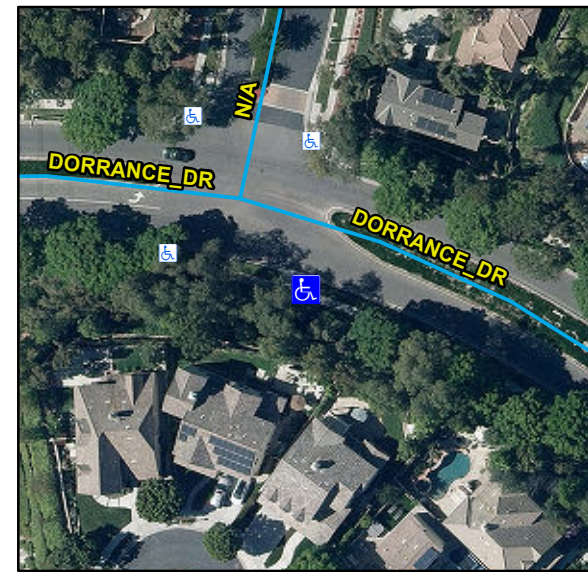
R304.2.2, R304.5.3, STD 1115

| Compliance | Description | Data | Compliance | Description | Data |
|---|---|---|---|---|---|
| No | Ramp Run Slope (%) | 8.6 | N/A | Flare Slope LT (%) | N/A |
| No | Ramp Cross Slope (%) | 5.2 | N/A | Flare Traversable LT | N/A |

Remove & Replace Entire Ramp.
