# Access Compliance Report Public Rights-of-Way (Curb Ramps)

| Main Street: FOLLATE_WAY | | Cross Street: FOLLATE_WAY | | Location: | W |
| ADA ID: RPRK220225191638 | Ramp Type:Type 1 - Perpendicular | Initial Pass/Fail: Fail | Overall Compliance: No | Severity Score: | 19 |

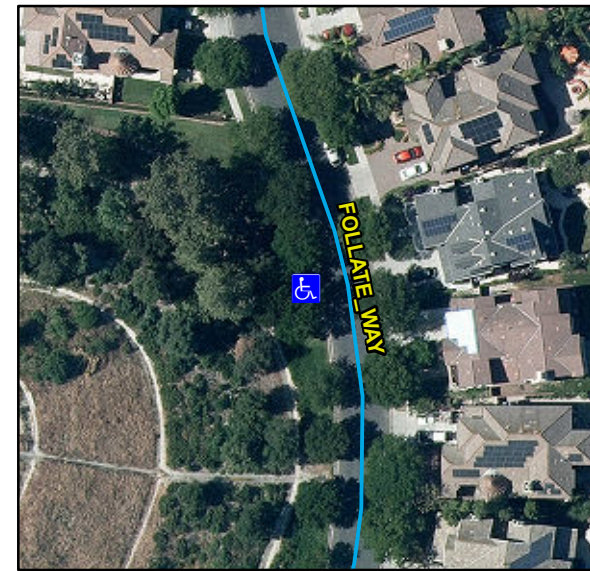
| Compliance | Description | Data | Compliance | Description | Data |
|---|---|---|---|---|---|
| No | Ramp Width (in) | 44 | | | N/A |
| No | Ramp Run Slope (%) | 8.7 | N/A | Flare Slope LT (%) | N/A |

Remove & Replace Entire Ramp.

R304.2.2, R304.5.1, STD 1115
