# Access Compliance Report Public Rights-of-Way (Curb Ramps)

Main Street: SIENNA\_PKWY Cross Street: N/A Location: NE

ADA ID: RPRK220225192825 Ramp Type: Type 1 - Perpendicular Initial Pass/Fail: Fail Overall Compliance: No Severity Score: 19

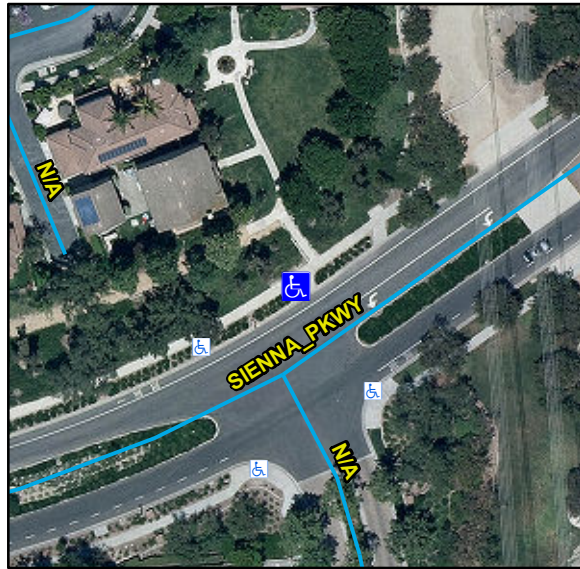
| Compliance | Description | Data | Compliance | Description | Data |
|---|---|---|---|---|---|
| No | Ramp Width (in) | 44 | | | N/A |
| No | Ramp Run Slope (%) | 9.8 | N/A | Flare Slope LT (%) | N/A |
| N/A | Gutter Ponding | N/A | No | Curb Slope | 11.2 |

Remove & Replace Entire Ramp.

R304.2.2, R304.5.1, STD 1115

Total Cost: \$ 3080
