# Access Compliance Report Public Rights-of-Way (Curb Ramps)

Main Street: ESENCIA\_DR Cross Street: ESENCIA\_DR Location: SE

ADA ID: RPRK220225195531 Ramp Type: Type 6 - Directional 1 Initial Pass/Fail: Pass Overall Compliance: No Severity Score: 6

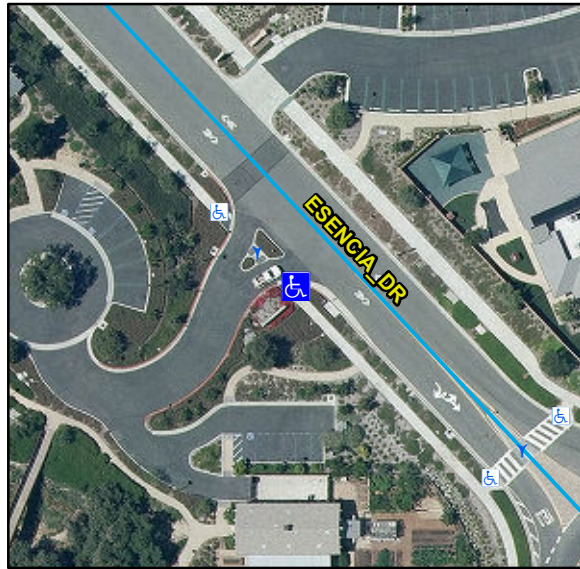
| Compliance | Description | Data | Compliance | Description | Data |
|---|---|---|---|---|---|
| No | Gutter Run Slope (%) | 5.5 | | Road Cross Slope (%) | N/A |

Remove & Replace Gutter.
