# Access Compliance Report Public Rights-of-Way (Curb Ramps)

Main Street: PACIFIC\_AVE Cross Street: GILBERT\_ST Location: SE

ADA ID: RPT1210915175157 Ramp Type: Type 4 - Parallel Initial Pass/Fail: Pass Overall Compliance: No Severity Score: 0

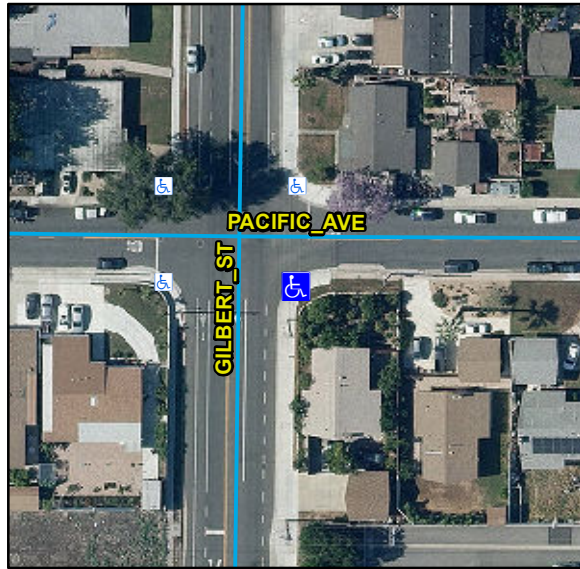
| Compliance | Description | Data | Compliance | Description | Data |
|---|---|---|---|---|---|
| Yes | Gutter Ponding | No | No | Curb Slope | 9 |

**Remove & Replace Curb Slope.**

**R304.2.2, STD 1115**
