# Access Compliance Report Public Rights-of-Way (Curb Ramps)

Main Street: GILBERT\_ST Cross Street: PACIFIC\_AVE Location: NE

ADA ID: RPT1210915182939 Ramp Type: Type 4 - Parallel Initial Pass/Fail: Pass Overall Compliance: Yes Severity Score: 0

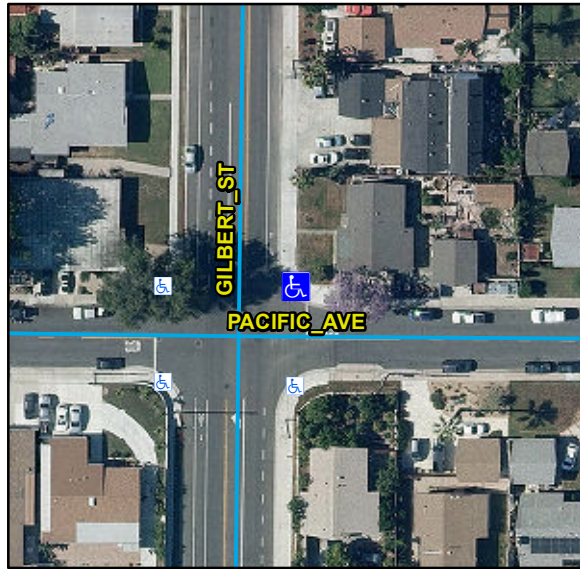
| Compliance | Description | Data | Compliance | Description | Data |
|---|---|---|---|---|---|
| Yes | Overall Surface Condition | Acceptable | | | |

N/A
