# Access Compliance Report Public Rights-of-Way (Curb Ramps)

Main Street: PACIFIC\_AVE Cross Street: PATRICIA\_DR Location: NW

ADA ID: RPT1210915184518 Ramp Type: Type 1 - Perpendicular Diagonal Initial Pass/Fail: Fail Overall Compliance: No Severity Score: 30

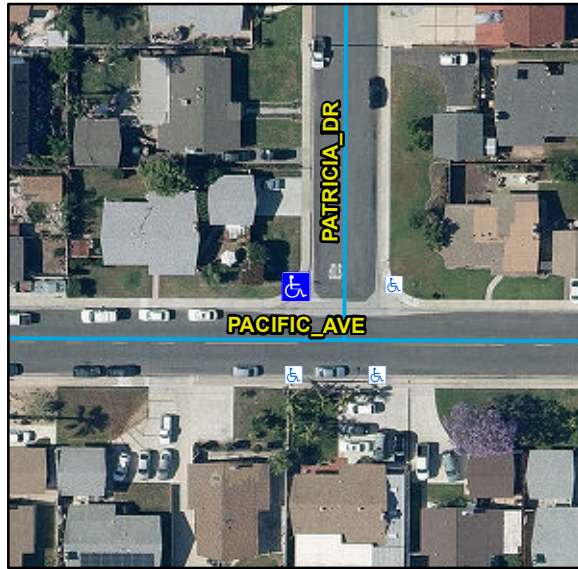
| Compliance | Description | Data | Compliance | Description | Data |
|---|---|---|---|---|---|
| No | Ramp Run Slope (%) | 13.7 | N/A | Flare Slope LT (%) | N/A |

Remove & Replace Curb Ramp With Two New Directional Ramps or Equivalent.

R304.2.2, STD 1115
