# Access Compliance Report Public Rights-of-Way (Curb Ramps)

Main Street: PATRICIA\_DR Cross Street: PACIFIC\_AVE Location: NE

ADA ID: RPT2210915161310 Ramp Type: Type 1 - Perpendicular Diagonal Initial Pass/Fail: Fail Overall Compliance: No Severity Score: 30

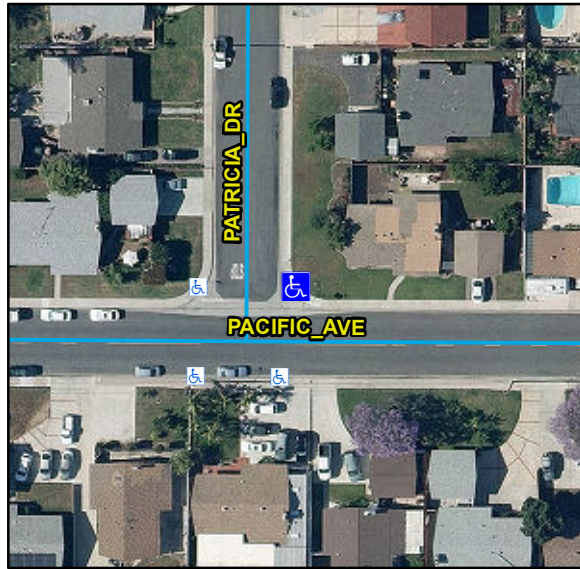
**R304.2.2, STD 1115**

| Compliance | Description | Data | Compliance | Description | Data |
|---|---|---|---|---|---|
| No | Ramp Run Slope (%) | 14.8 | N/A | Flare Slope LT (%) | N/A |

**Remove & Replace Curb Ramp With Two New Directional Ramps or Equivalent.**
