# Access Compliance Report Public Rights-of-Way (Pedestrian Signals)

| Main Street: VALENCIA_AVE | | Cross Street: BIRCH_ST | | Location: SW | |
| ADA ID: SGAT210920140844 | | Signal Type: One Push Button-APS | | Overall Compliance: No | |

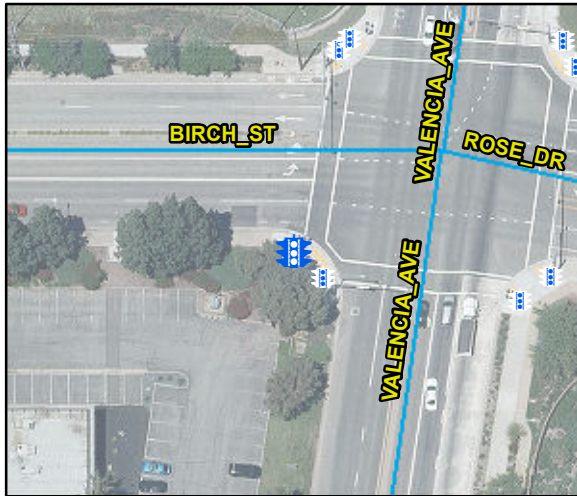
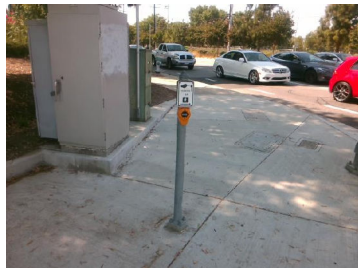
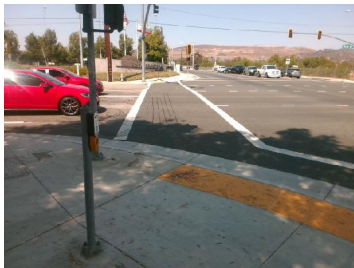
| | | Severity Scores: | | BTN 1: 0 BTN 2: N/A No BTN: N/A | |

| Compliance | Description | Data | Compliance | Description | Data |
|---|---|---|---|---|---|
| No | B 1 DistanceTo Curb (in) | 118 | N/A | B 2 DistanceTo Curb (in) | N/A |

Possible Solutions: Replace Signal Push Button With APS Button. Remove & Relocate Sign.

OC Std/PROW: MUTCD 4e.08

Total Cost: \$ 650
