# Access Compliance Report Public Rights-of-Way (Pedestrian Signals)

Main Street: KELLOGG\_DR Cross Street: KELLOGG\_DR Location: N

ADA ID: SGAT210922100815 Signal Type: One Push Button-Non APS Overall Compliance: No Severity Scores: BTN 1: 35 BTN 2: N/A No BTN: N/A

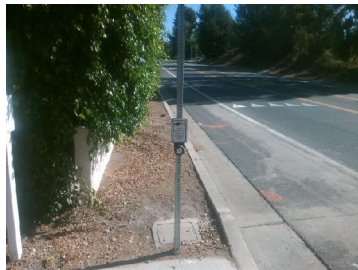
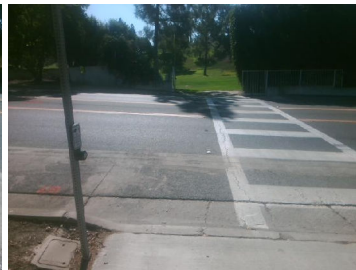
| Compliance | Description | Data | Compliance | Description | Data |
|---|---|---|---|---|---|
| No | B 1 Clear Floor Space? | No | N/A | B 2 Clear Floor Space? | N/A |

| No | B 1 Pilot Light? | No | N/A | B 2 Pilot Light? | N/A |

Possible Solutions: Replace Signal Push Button With APS Button. Provide Clear Space.

OC Std/PROW: R404.1, MUTCD 4e.08

Total Cost: \$ 1278
